DEPARTMENT OF TRANSPORTATION

Contract #: 04-0120F4Cty: SF/ALA Rte: 80 PM: 13.2/13.9File #: xx.28**WELDING INSPECTION REPORT****Resident Engineer:**Siegenthaler, Peter**Address:** 333 Burma Road**City:** Oakland, CA 94607**Report No:** WIR-022111**Date Inspected:** 19-Mar-2011**Project Name:** SAS Superstructure**OSM Arrival Time:** 700**Prime Contractor:** American Bridge/Fluor Enterprises, a JV**OSM Departure Time:** 1900**Contractor:** Zhenhua Port Machinery Company, Ltd (ZPMC), Changxing Island **Location:** Shanghai China**CWI Name:** Mr. Zhu Zhong Hai.**CWI Present:** Yes No**Inspected CWI report:** Yes No N/A**Rod Oven in Use:** Yes No N/A**Electrode to specification:** Yes No N/A**Weld Procedures Followed:** Yes No N/A**Qualified Welders:** Yes No N/A**Verified Joint Fit-up:** Yes No N/A**Approved Drawings:** Yes No N/A**Approved WPS:** Yes No N/A**Delayed / Cancelled:** Yes No N/A**Bridge No:** 34-0006**Component:** OBG Trial Assembly**Summary of Items Observed:**

WELDING INSPECTION REPORT

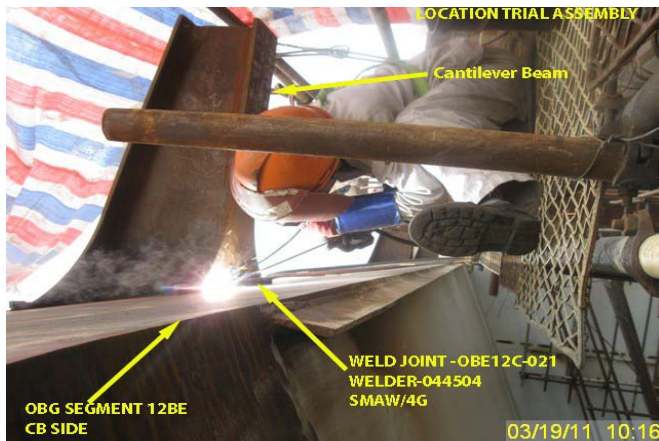
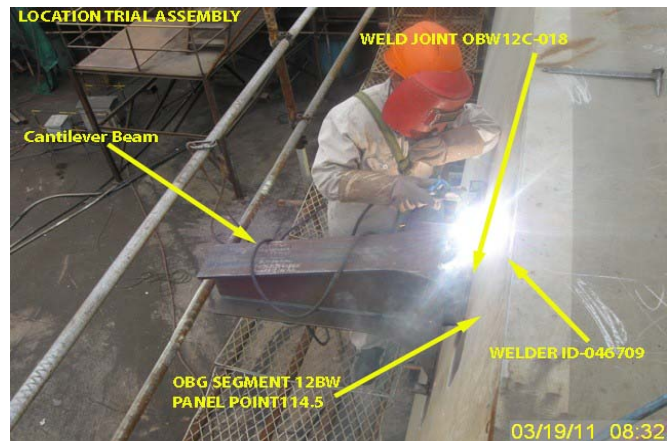
Unless otherwise noted, all work observed on this date appeared to be in general compliance with the applicable contract documents.
